INDOOR AIR QUALITY ASSESSMENT

**McDonough City Magnet School
43 French Street
Lowell, Massachusetts**

Prepared by:
Massachusetts Department of Public Health
Bureau of Environmental Health Assessment
January, 2001

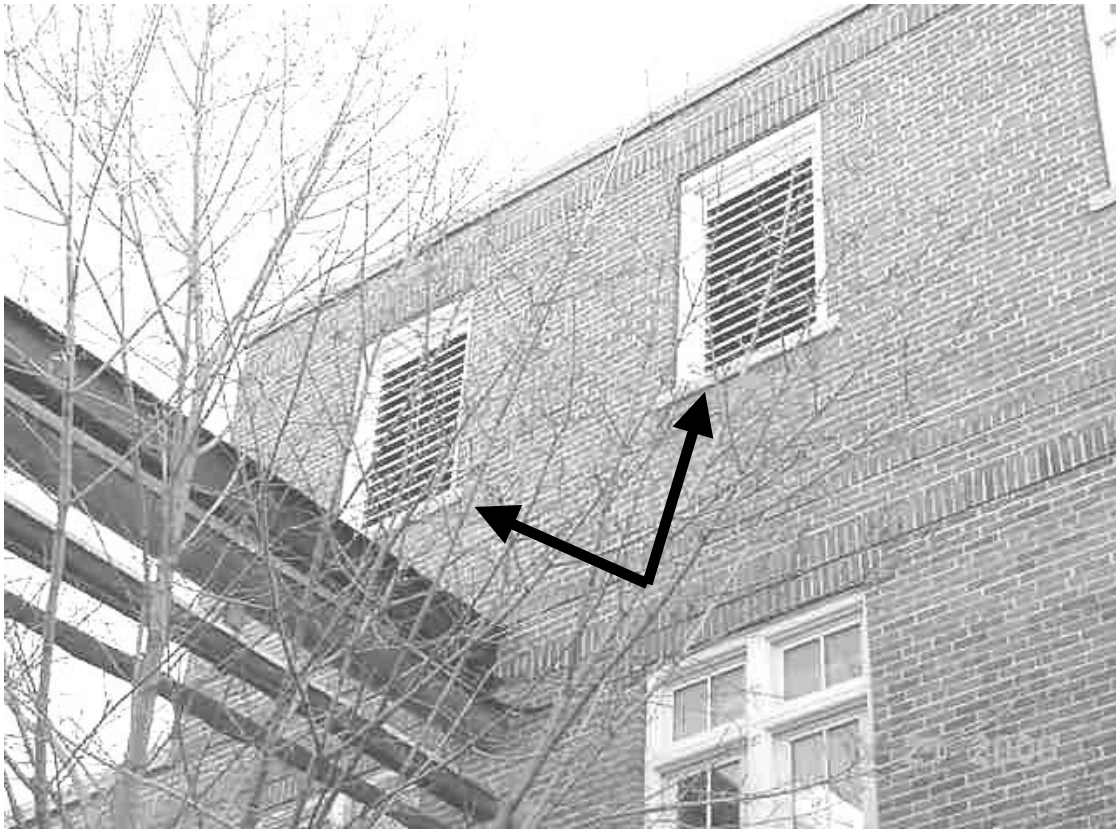
Picture 1

Ventilation is provided by a single AHU located in a penthouse on the roof of the school (see Picture 1). Fresh air is distributed via ductwork connected to wall-mounted air diffusers in classrooms (see Picture 2). The amount of fresh air drawn into the unit is controlled by moveable louvers connected to an activator motor that adjusts to alter fresh air intake. Exhaust ventilation is provided by wall-mounted grates that return air back to the AHU via ductwork. This system was operating during the assessment.

Fresh Air Intakes for HVAC Penthouse on Roof of City Magnet School

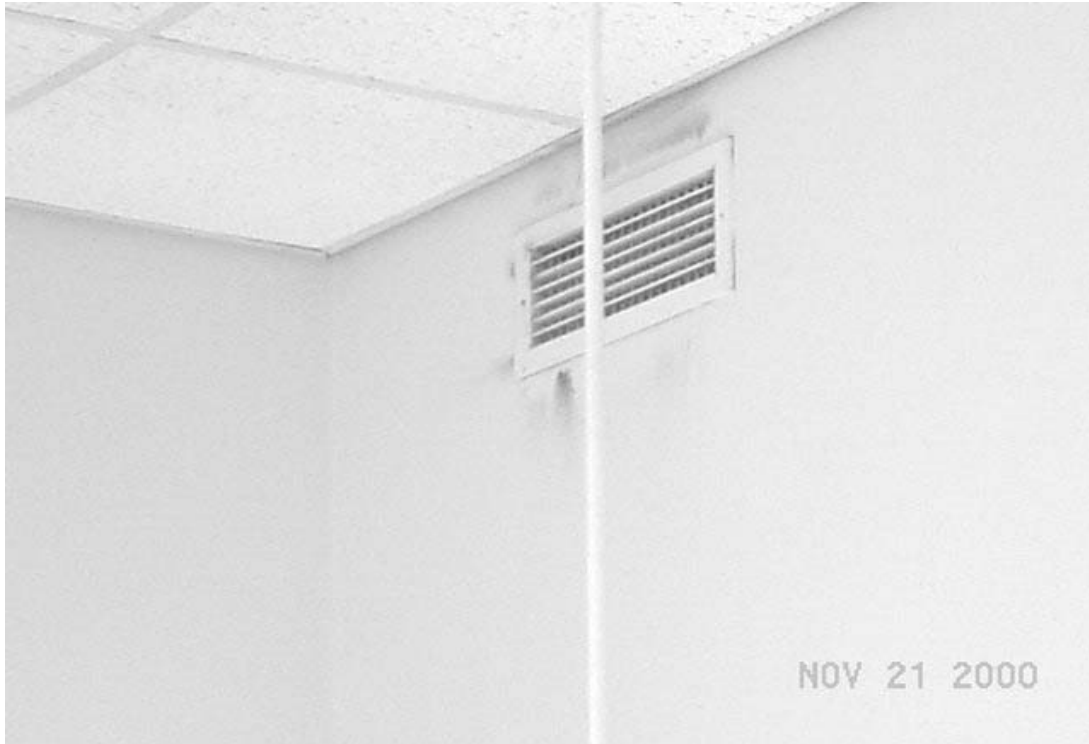
Picture 2

Wall-Mounted Fresh Air Diffuser

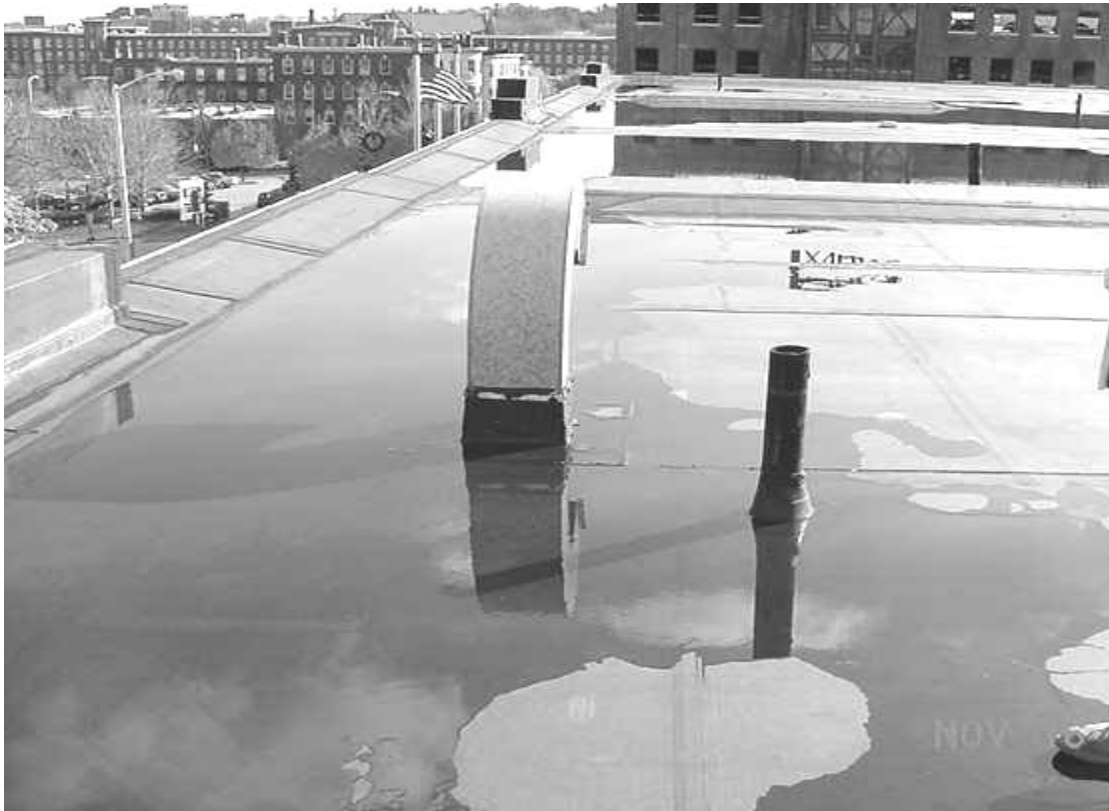
Picture 3

Standing water was noted in a number of areas on the roof (see Picture 3). The collection of water and its subsequent freezing and thawing during winter months can lead to roof leaks resulting in water penetration into the interior of the building. Pooling water can also become stagnant, which can lead to mold and bacterial growth, resulting in unpleasant odors and providing a breeding ground for mosquitoes in warmer months. Water damaged ceiling tiles were observed in a number of areas (see Picture 4). Room

Water Pooling on Roof

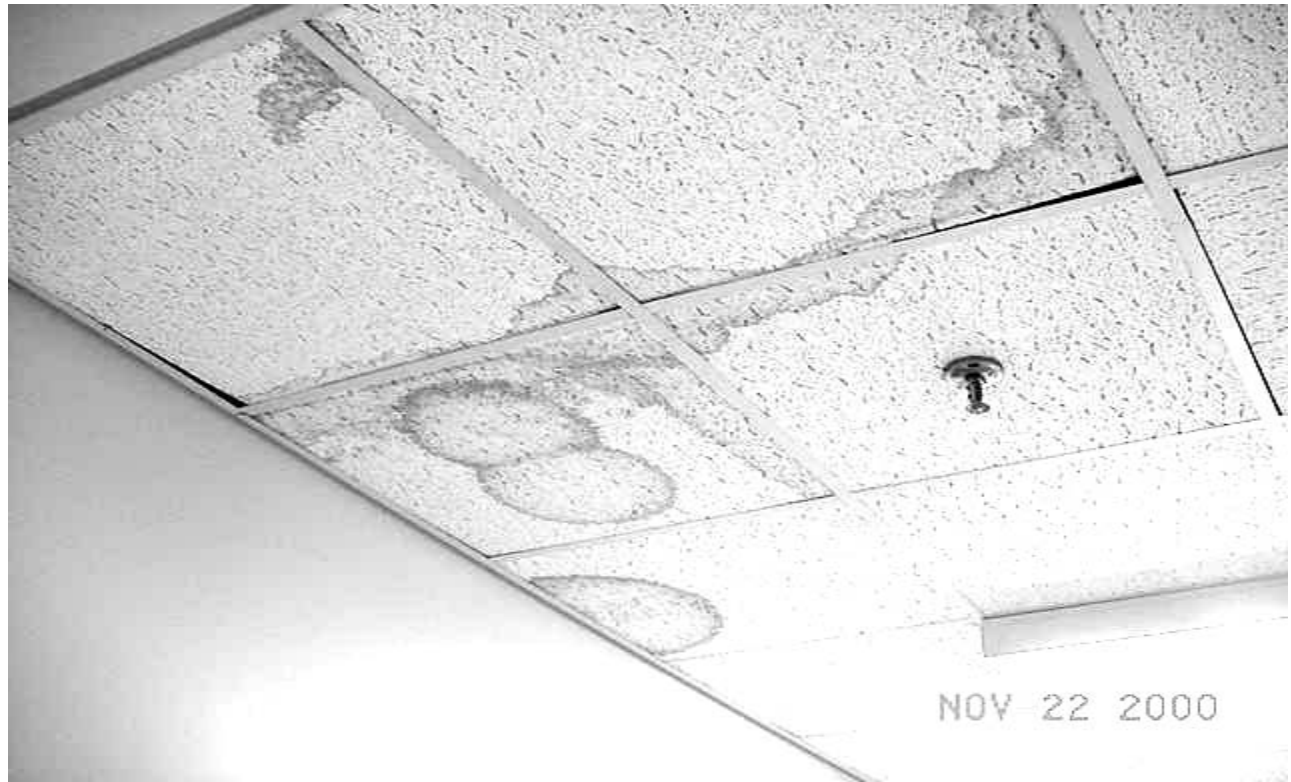
Picture 4

213 contained a ceiling tile with possible mold growth. Water-damaged ceiling tiles can provide a source of mold and mildew and should be replaced after a water leak is discovered.

Water Damaged Ceiling Tiles

4. Repair any water leaks and replace any remaining water-stained ceiling tiles. Examine the areas above these tiles for mold growth. Disinfect areas of water leaks with an appropriate antimicrobial as needed.

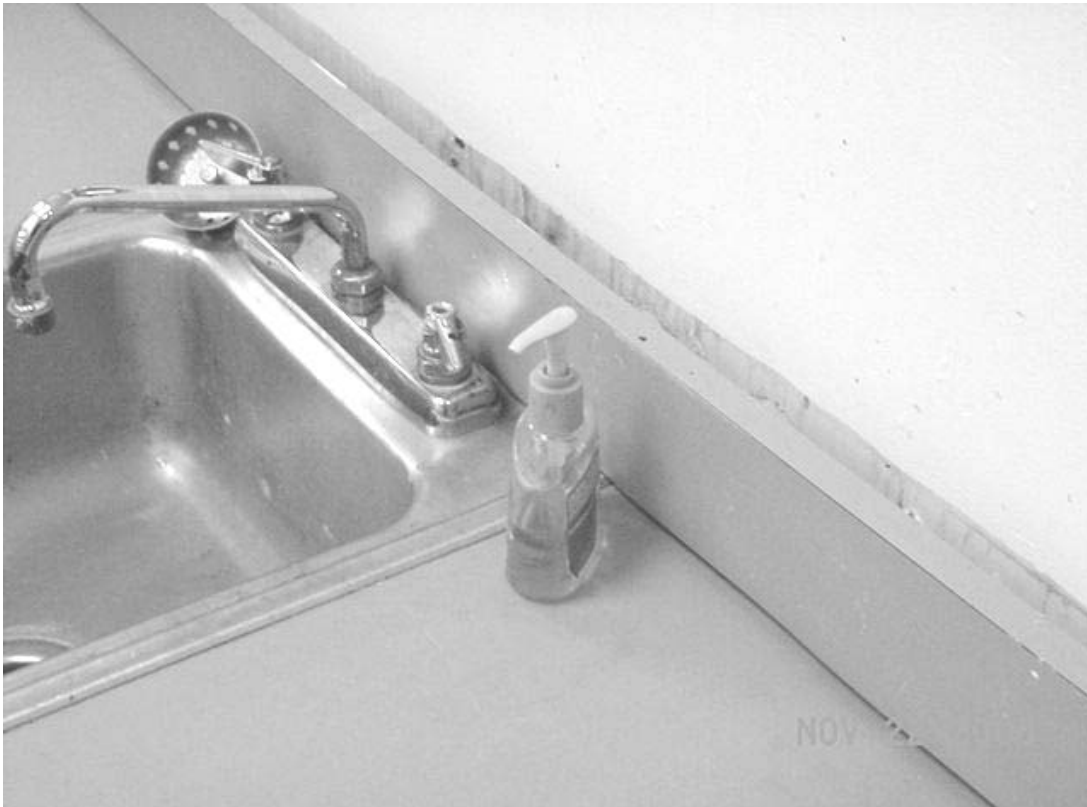
Picture 5

In a number of classrooms, spaces between the sink countertop and backsplash were noted (see Picture 5). A leaking faucet was noted in the health suite. Repeated leakage or improper drainage/overflow can lead to water penetration of countertop wood, the cabinet interior and behind cabinets. Like other porous materials, if these materials become wet repeatedly it can provide a medium for mold growth.

**Spaces between Backsplash and Sink Countertop,
Also Note Space between Backsplash and Wallboard**

5. Ensure plants have drip pans. Examine drip pans for mold growth and disinfect areas with an appropriate antimicrobial where necessary.
6. Seal areas around sinks to prevent water-damage to the interior of cabinets and adjacent wallboard. Inspect wallboard for water-damage and mold/mildew growth, repair/replace as necessary. Disinfect areas of microbial growth with an appropriate antimicrobial as needed.

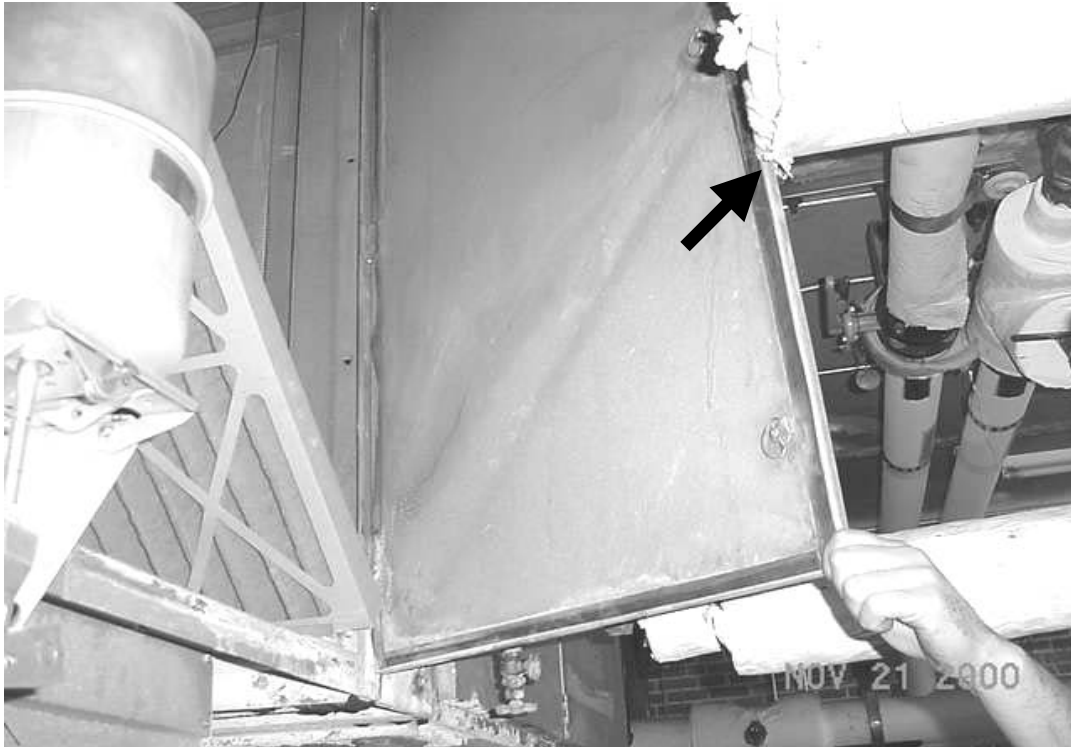
Picture 6

BEHA staff examined the interior of the AHU and noted filters coated with dirt/dust and accumulated material. This condition obstructs airflow through the filters, and may serve to reaerosolize and distribute pollutants to occupied areas via the ventilation system. In addition, the configuration of pipes around the AHU filter rack obstructs the opening of the filter rack access panel (see Picture 6). To gain access to filters the hinges securing the filter rack access panel must be loosened to remove the panel.

Filter Bank Access Panel Obstructed by Pipe

11. Change filters for HVAC equipment as per the manufacturer's instructions, or more frequently if needed. Clean and vacuum interior of units prior to operation to avoid the re-aerosolization of accumulated dirt, dust and debris.

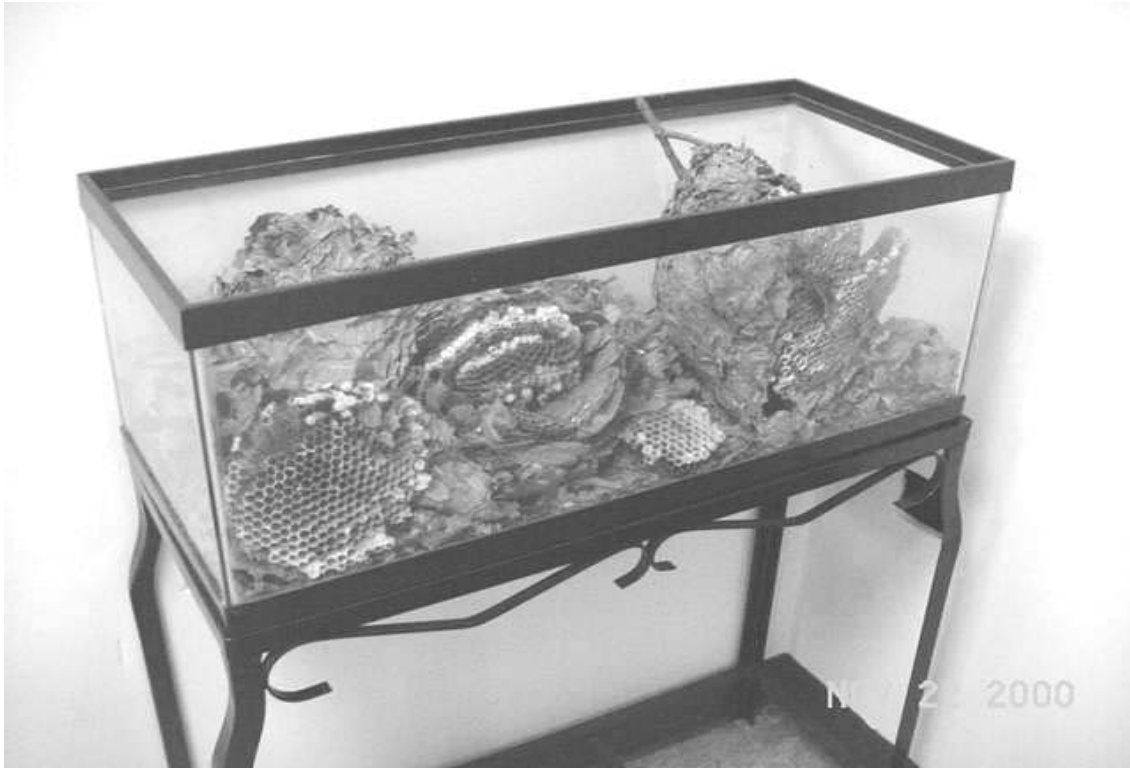
Picture 7

Several inactive bee hives/wasps nest were noted in the science museum, which reportedly serve as learning tools (see Picture 7). Insect parts can become dried out and aerosolized and may serve as a source of allergenic material for certain sensitive individuals. Several areas had missing/or dislodged ceiling tiles (see Picture 8). The movement of ceiling tiles can introduce dirt, dust and particulate matter into occupied areas of the school. Accumulated chalk dust was noted in several classrooms. Chalk

Inactive Bee Hives & Wasps/Hornets Nests in Science Museum

13. Ensure exhaust ventilation is operating during photocopying to help remove excess heat and odors.
14. Keep wasps' nest away from ventilation equipment and open windows to prevent the aerosolization of potentially allergenic materials. Consider bringing in items on an "as needed" basis.
15. Clean chalkboards and chalktrays regularly to prevent the build-up of excessive chalk dust.
16. Close classroom windows and doors adjacent to the boiler plant during wind/weather conditions conducive for the entrainment of exhaust odors. Consider extension of the boiler exhaust vent pipes if problem persists.
17. It is highly recommended that the principles of integrated pest management (IPM) be used to rid this building of pests. A copy of the Massachusetts IPM recommendations are included with this report as Appendix A (MDFA, 1996).

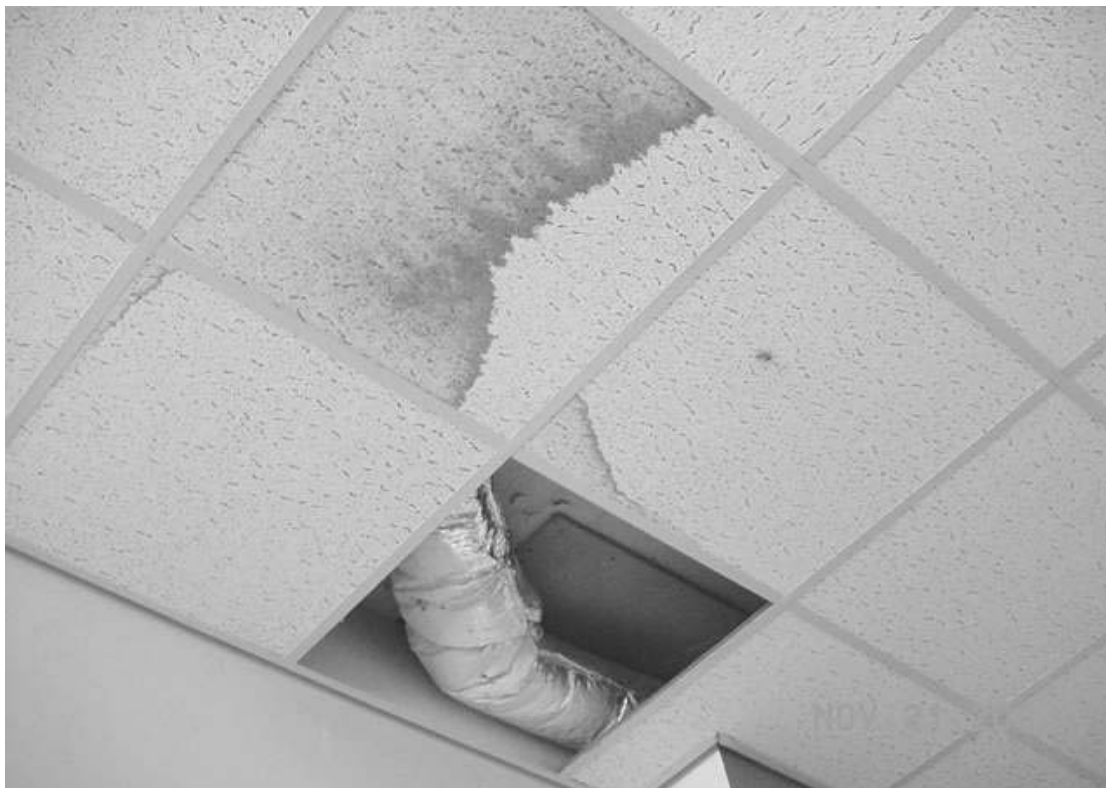
Picture 8

Missing Ceiling Tile

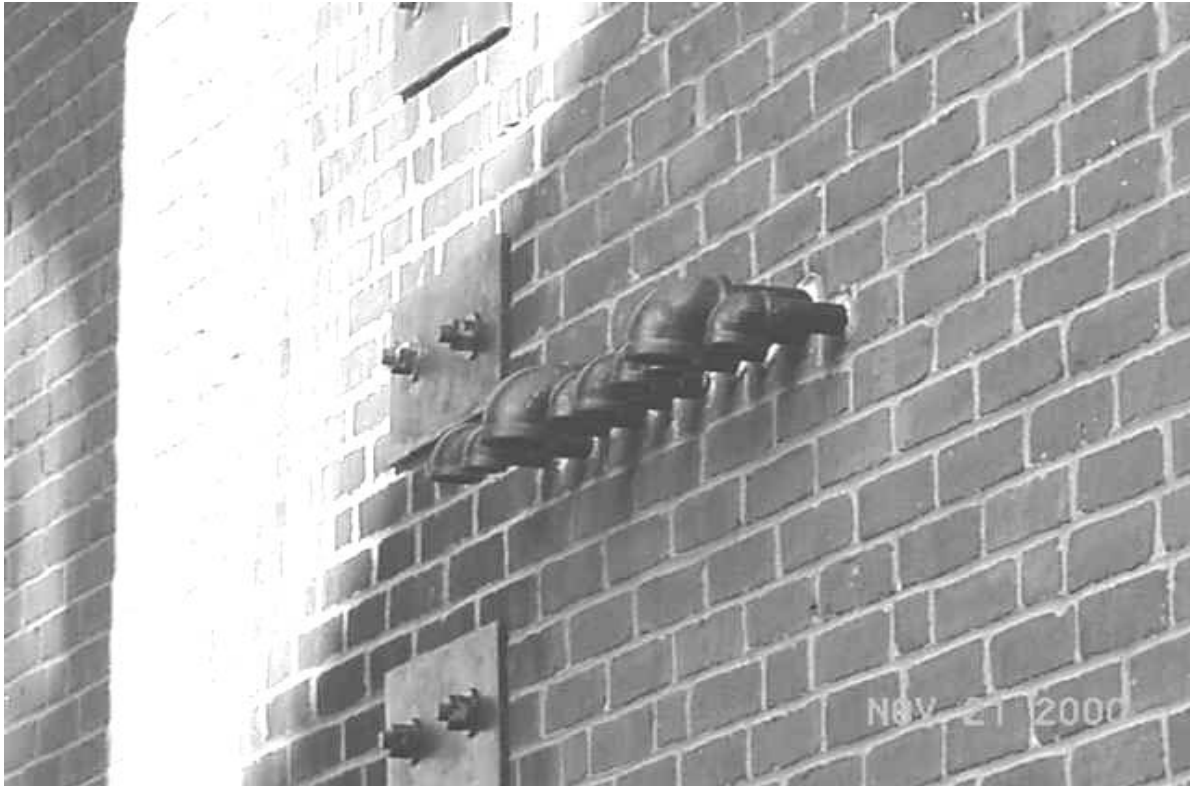
Picture 9

School officials reported a reoccurring problem with exhaust entrainment from the boiler plant located adjacent to the school. Although no odors of exhaust emissions or measurable levels of carbon monoxide were noted indoors by BEHA staff on the day of the assessment, the possibility of entrainment does exist. The boilers release emissions from a series of vent pipes approximately 10-15' below the plant roof (see Picture 9). Certain wind and weather conditions can result in the entrainment of these exhaust emissions into open windows or air intakes of the adjacent school building (see Picture 1), which may, in turn, provide opportunities for exposure to products of combustion such as carbon monoxide. Boiler exhaust and wind conditions should be closely monitored to avoid the entrainment of emissions inside the building via open doors, windows and/or AHU fresh air intakes.

Boiler Plant Vent Pipes

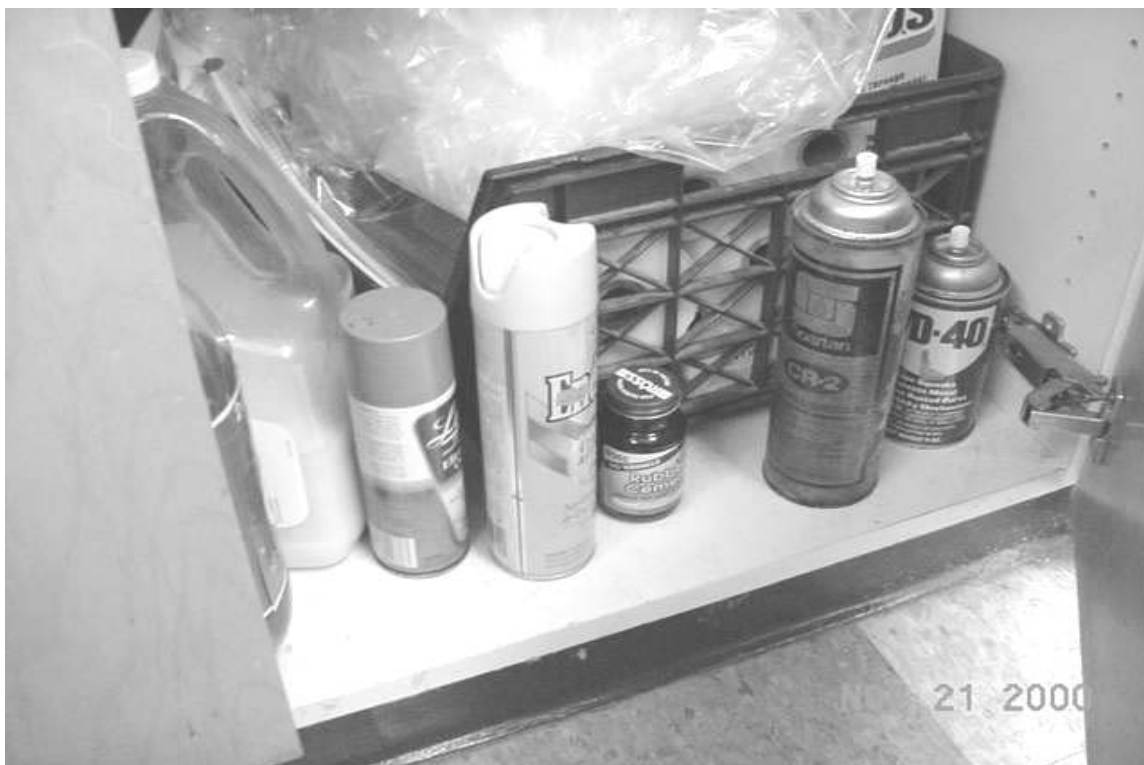
Picture 10

A number of classrooms contained cleaning products under sinks and on counter tops. Classroom 117 had flammable materials and a spray can of insecticide under the sink (see Picture 10). Insecticides, cleaning products and other flammable materials contain VOCs, which can cause eye, throat and respiratory irritation. In addition, applicators of pesticides should be in full compliance with federal and state rules and regulations that govern pesticide use, including posting and notification requirements (333 CMR 13.10). Under no circumstances should pest controlling products be applied

Cleaning Products and Flammables under Sink in Classroom

by untrained personnel. Such products should not be applied prior to or during school hours. If application must be done during the school week, they should be applied shortly after the school day ends, in order to give the applied areas ample time to dry. Flammable materials found in classrooms should be stored in a storage cabinet that meets design criteria set forth by the National Fire Protection Association (NFPA, 1996).

8. Secure gas cylinders to prevent accidental discharge.
9. Store chemicals and cleaning products properly and out of the reach of students.
10. Store flammable materials in flameproof cabinets consistent with local and state fire codes.

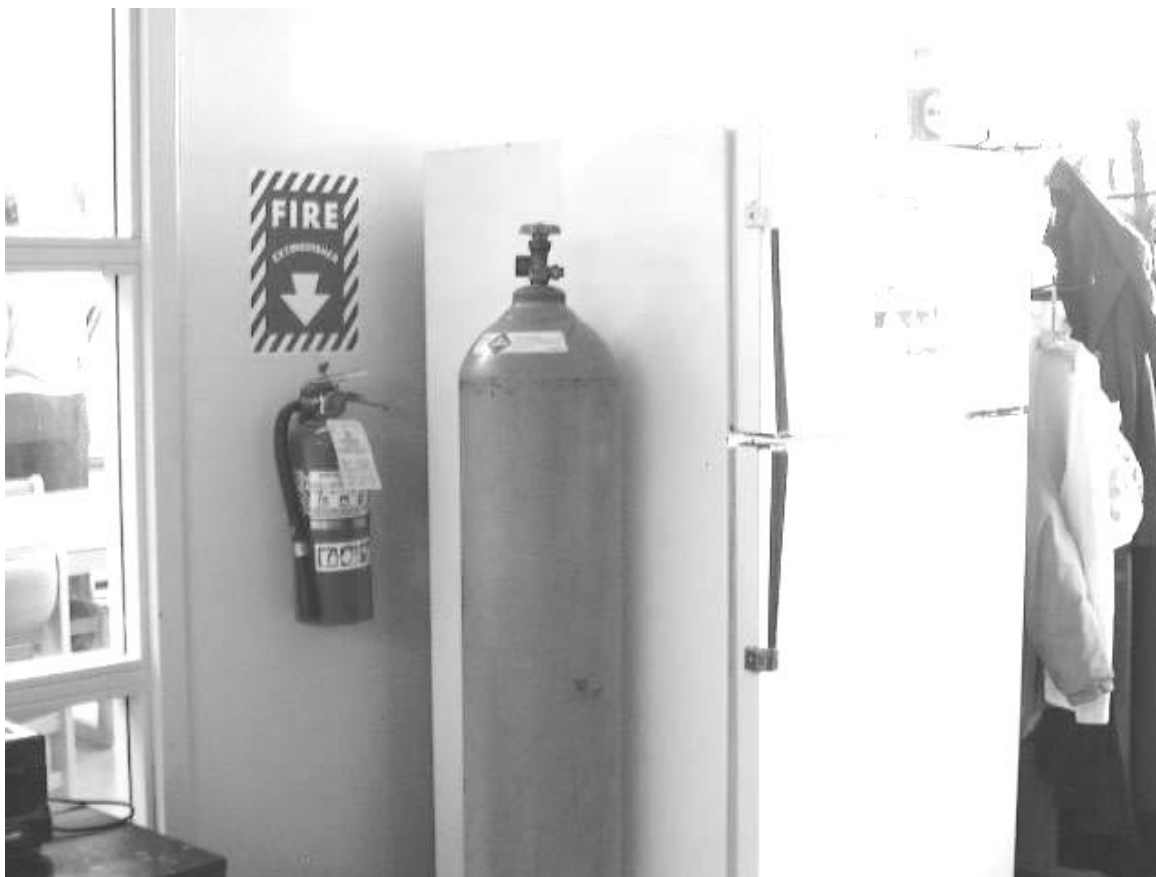
Picture 11

The teacher's room contained an unsecured helium tank standing against the refrigerator (see Picture 11). Cylinders of compressed gas should be fixed to a wall or stand to prevent damage to the cylinder valves by tipping. A damaged cylinder valve can cause an immediate and uncontrolled release of the cylinder contents and may result in the cylinder becoming a projectile.

Unsecured Helium Cylinder in Teachers' Lounge
